Manhole Inspection Summary

Manhole # S49CC_055MH

Printed On: 6/24/2010

Insp Date: **2/15/08 9:27 AM**

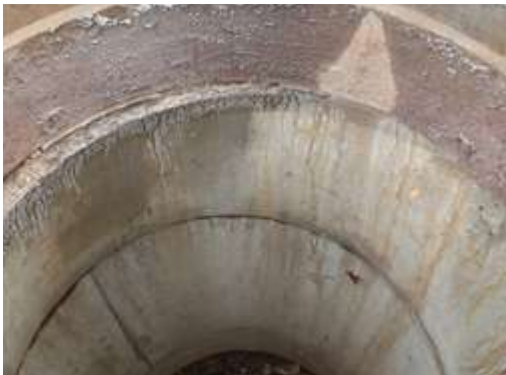
Defect 2

Frame Offset: **1** (in.) Condition: ☐ Sound ☐ Cracked ☒ **Leaks**

Frame Leaks

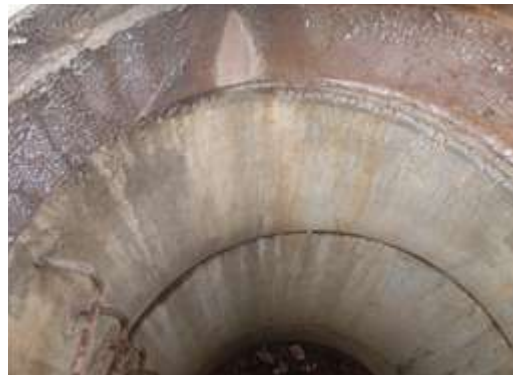
Defect 1

Infiltration: ☐ None ☒ **Joint** ☐ Cracks ☐ Mortar ☐ Roots ☐ Wall

Adjustmet Joint

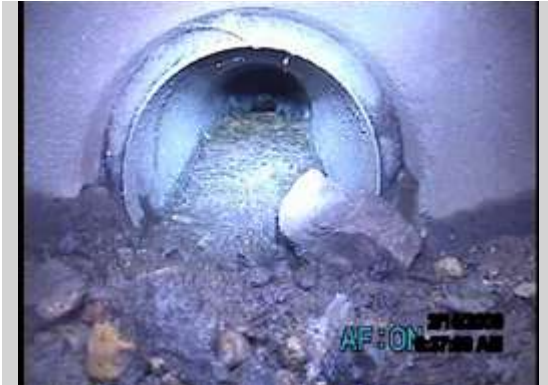
12 O'Clock Outflow

8 in. Circular Gravity Sewer
Pipe Out @ 12 O'Clock

Deposits: ☐ None ☐ Mud ☐ Sludge ☒ **Debris** ☐ Grease

Silt Depth: **1** (in.) Deposits Extent: **Light**
